# CHEMICAL ANALYSIS OF THE POLYESTER/METAL SURFACE OF A DELAMINATION FAILURE

*Eldridge M. Mount III*  
*EMMOUNT Technologies*  
*Fairport, NY, 14450*  
*United States*

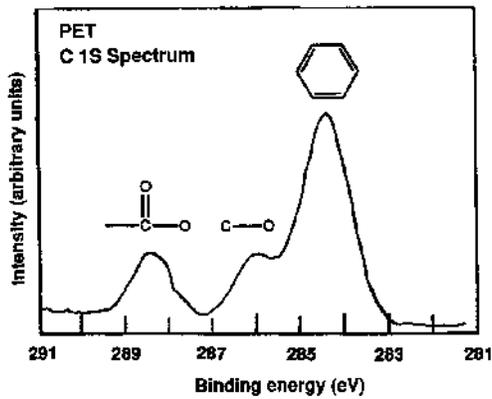
Figure 3a: Oxygen 1S spectrum for PET

Figure 3a and 3b shows the typical high resolution oxygen and carbon 1S spectra for a PET polymer surface. In figure 3a we note the symmetrical peaks for the C-O and C=O 1S spectra due to the equal number of C-O and C=O functional groups in the PET molecule.

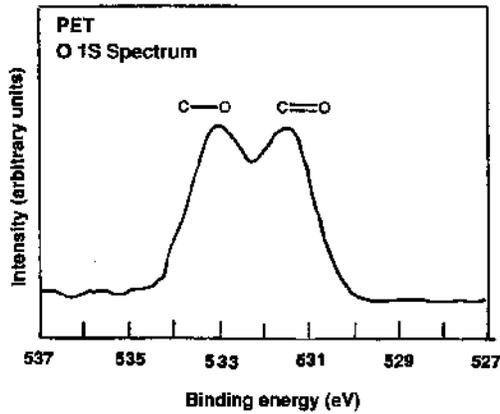
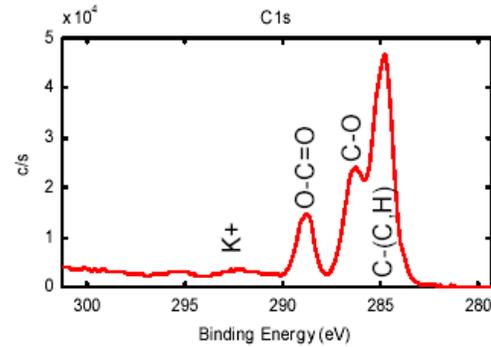
Figures 4a ,4b, 5,a, 5b, 6a & 6b show the high resolution XPS oxygen and carbon 1S spectra for the exposed PET surfaces of samples 1, 2 & 3 respectively. It is clear from these figures that the PET surface of samples 2 & 3 has been chemically changed from the native PET polymer surface.

It is clear from the XPS analysis of the good (sample 1) and bad (samples 2 & 3) laminations that the metallized PET surface of samples 2 & 3 have been chemically modified in some fashion which is increasing the concentration of C-O species at the film surface. This is perhaps indicative of an increase in acid O=C-OH and/or glycol C-OH end groups on the PET surface. This would imply that the PET surface has been reduced in molecular weight or that it contains an increase in reduced molecular weight PET which would be consistent with the presence of a weak boundary layer at the PET film/metal interface giving rise to the decreased bond strength and the increased metal lift in laminations 2 & 3. This chemical change of the PET surface was not seen in sample 1 which exhibited acceptable lamination bond strength.

Figure 5a & 5b: O1s and C1s spectra of exposed PET from sample #2 spectra showing excess C-O relative to typical of PET polymer surfaces

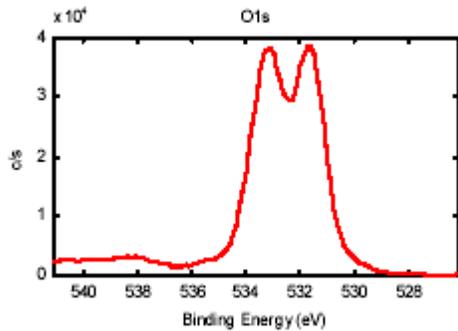
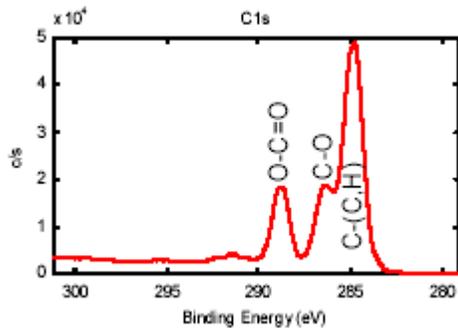
Figure 4a & 4bb, O1s and C1s spectra of exposed PET from sample #1 showing spectra typical of PET polymer surfaces

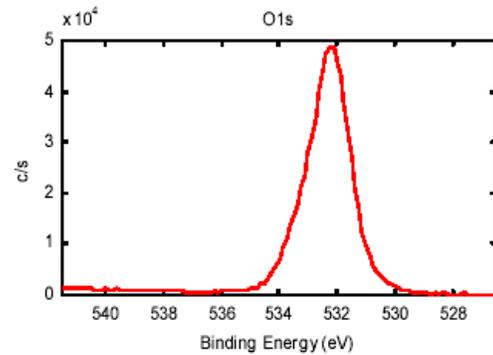
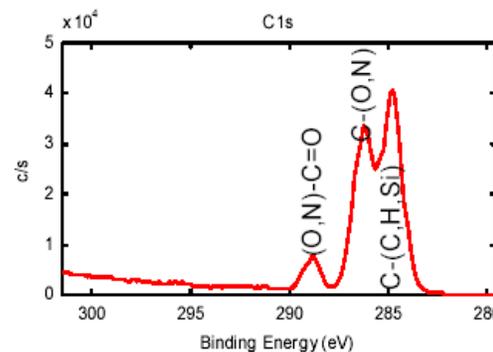
Figure 6a & 6b: O1s and C1s spectra of exposed PET from sample #3 spectra showing excess C-O relative to typical of PET polymer surfaces
